IMPACT RESISTANCE OF COMPOSITE FAN BLADES

GENERAL ELECTRIC COMPANY
AIRCRAFT ENGINE GROUP
Cincinnati, Ohio 45215

**NATIONAL AERONAUTICS AND SPACE ADMINISTRATION
NASA-LEWIS RESEARCH CENTER**

1. Report No. NASA CR-134707		2. Government Accession No.		3. Recipient's Catalog No.	
4. Title and Subtitle IMPACT RESISTANCE OF COMPOSITE FAN BLADES				5. Report Date December 1974

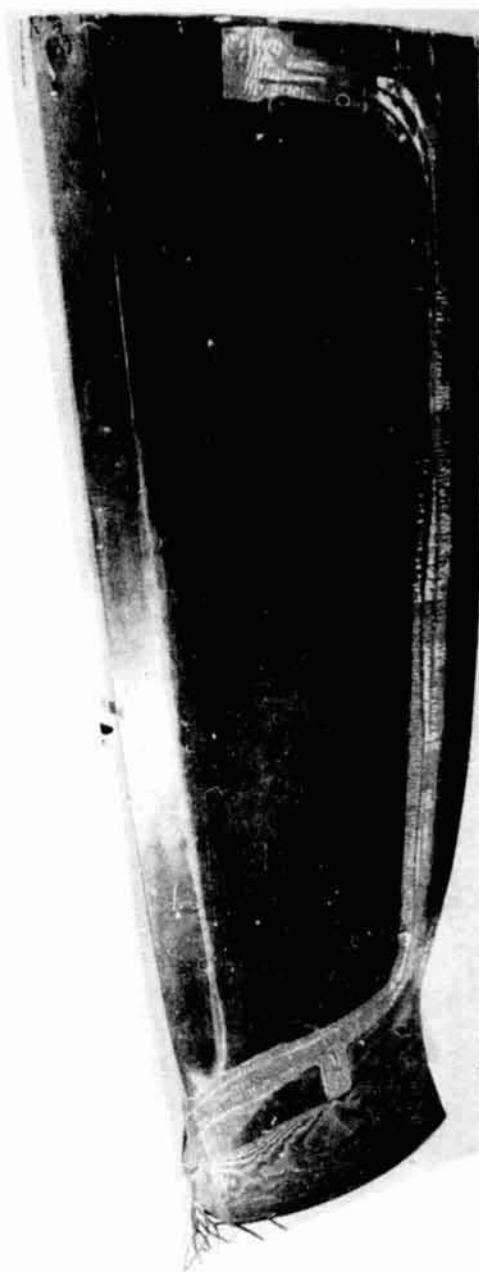
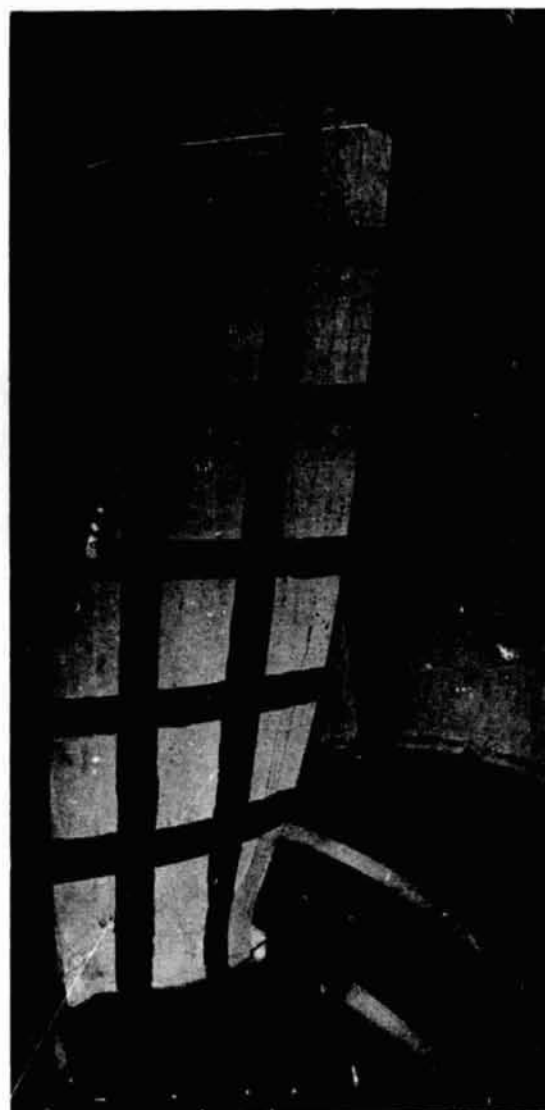
Figure 25. Blade S/N NB2 after Impact.

NASA-FOD Impact Resistance Test
 Blade S/N NB2
 Boron/Epoxy
 Tip Speed: 244 m/sec (800 ft/sec)
 340 g (12 oz) RTV Bird
 170 g (6 oz) Slice
 0.384 Radians (22°) Incidence Angle

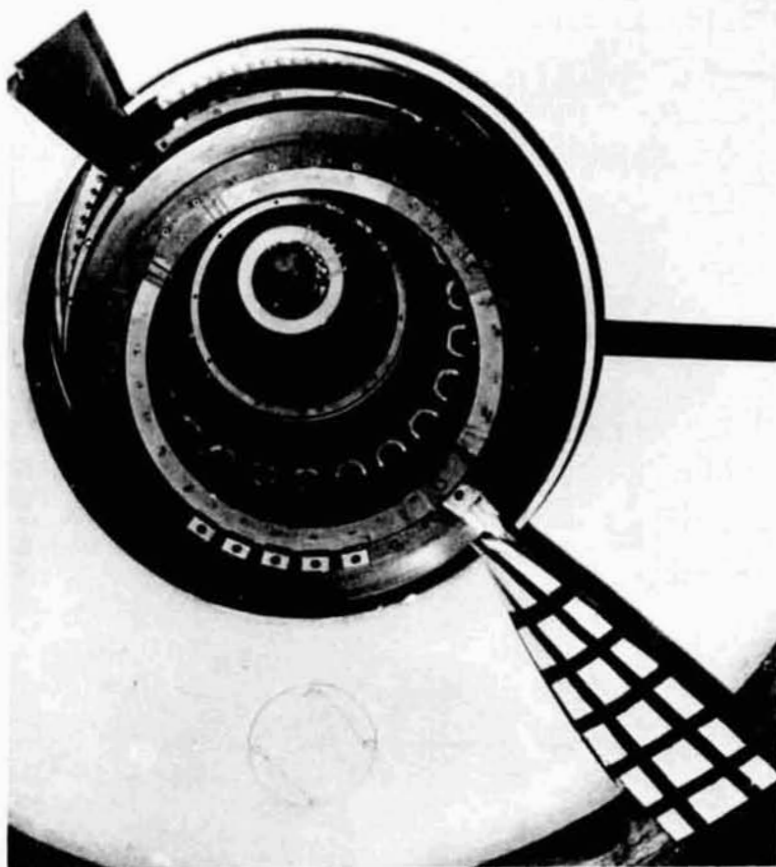
Figure 30. Blade S/N NGI after Impact.

NASA-FOD Impact Resistance Test
 Blade S/N NGI
 Graphite/Epoxy
 Tip Speed: 244 m/sec (800 ft/sec)
 340 g (12 oz) RTV Bird
 170 g (6 oz) Slice
 0.384 Radians (22°) Incidence Angle

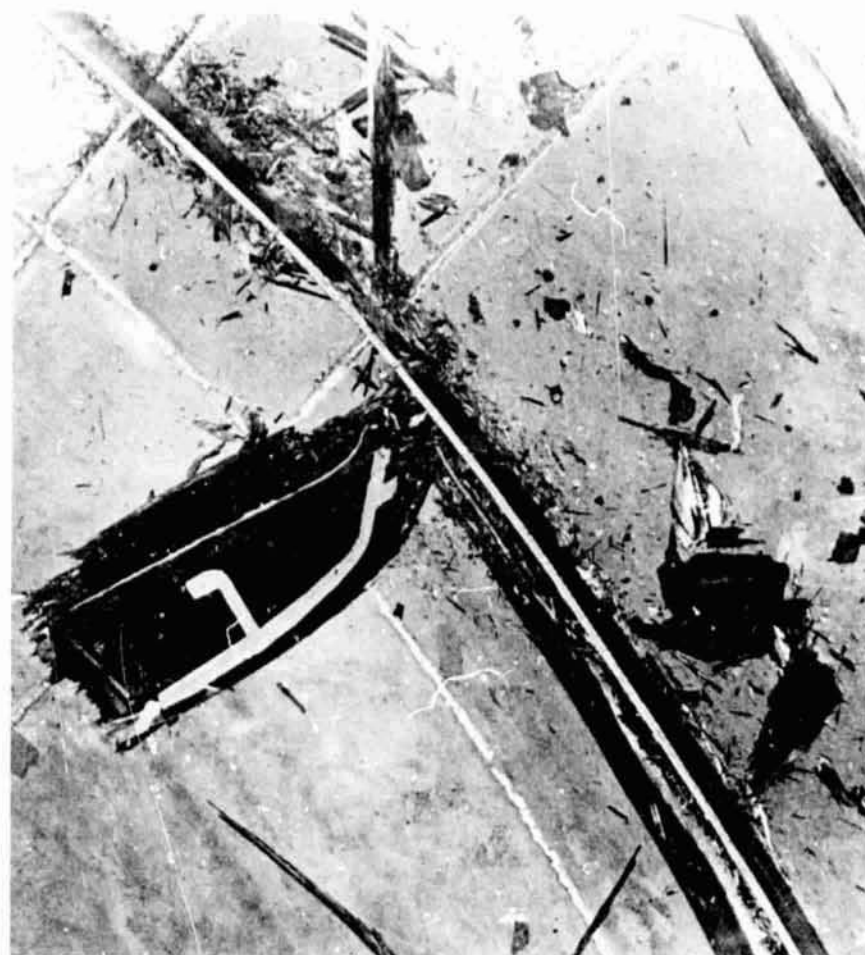
Figure 34. Blade S/N NG3 after Impact.

NASA-FOD Impact Resistance Test
 Blade S/N NG3
 Graphite/Epoxy
 Tip Speed: 244 m/sec (800 ft/sec)
 794 g (28 oz) RTV Bird
 340 g (12 oz) Slice
 0.384 Radians (22°) Incidence Angle

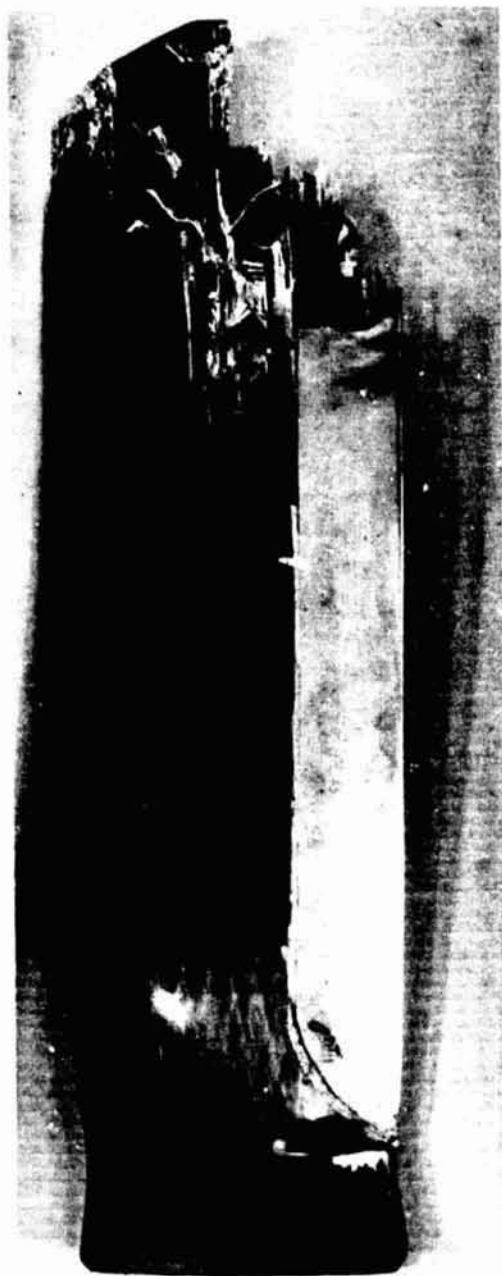
Figure 59. Blade S/N H/E3 After Impact.

NASA-FOD Program
Blade S/N H/E3
Design No. 2 Material
Real Mallard Duck
Bird Size: 1134 g (40 oz)
Slice Size: 680 g (24 oz)
Blade Tip Speed: 244 m/sec (800 ft/sec)
Incidence Angle: 0.384 Radians (22°)

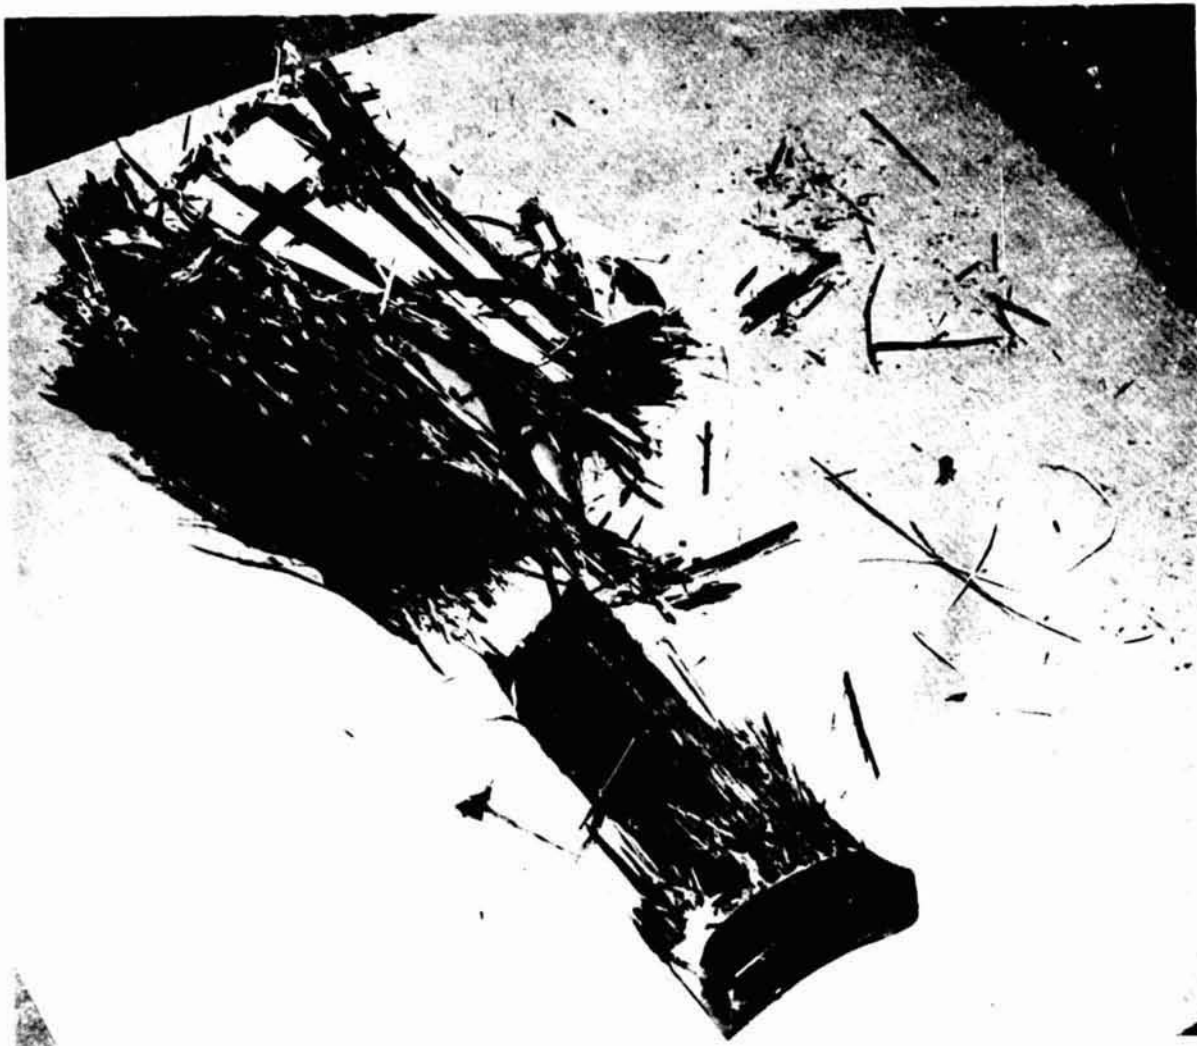
Figure 61. Blade S/N H/E5 After Impact.

NASA-FOD Program
Blade S/N H/E5
Design No. 1 Material
RTV Simulated Bird
Bird Size: 1360 g (48 oz)
Slice Size: 765 g (27 oz)
Blade Tip Speed: 244 m/sec (800 ft/sec)
Incidence Angle: 0.384 Radians (22°)

S/N H/E 5, H/E 6 - Both H/E 5 and H/E 6 sustained 100% delamination after impact with 765 g (27-oz) and 567 g (20-oz) slices of birds, respectively. H/E 5 broke off at the root, while H/E 6 remained in one piece. Figure 67 shows these blades prior to test.
